Eden Roc Hotel

Miami Beach, Florida

Submitted by Tadjer-Cohen-Edelson Associates, Inc.

2004 Award of Excellence

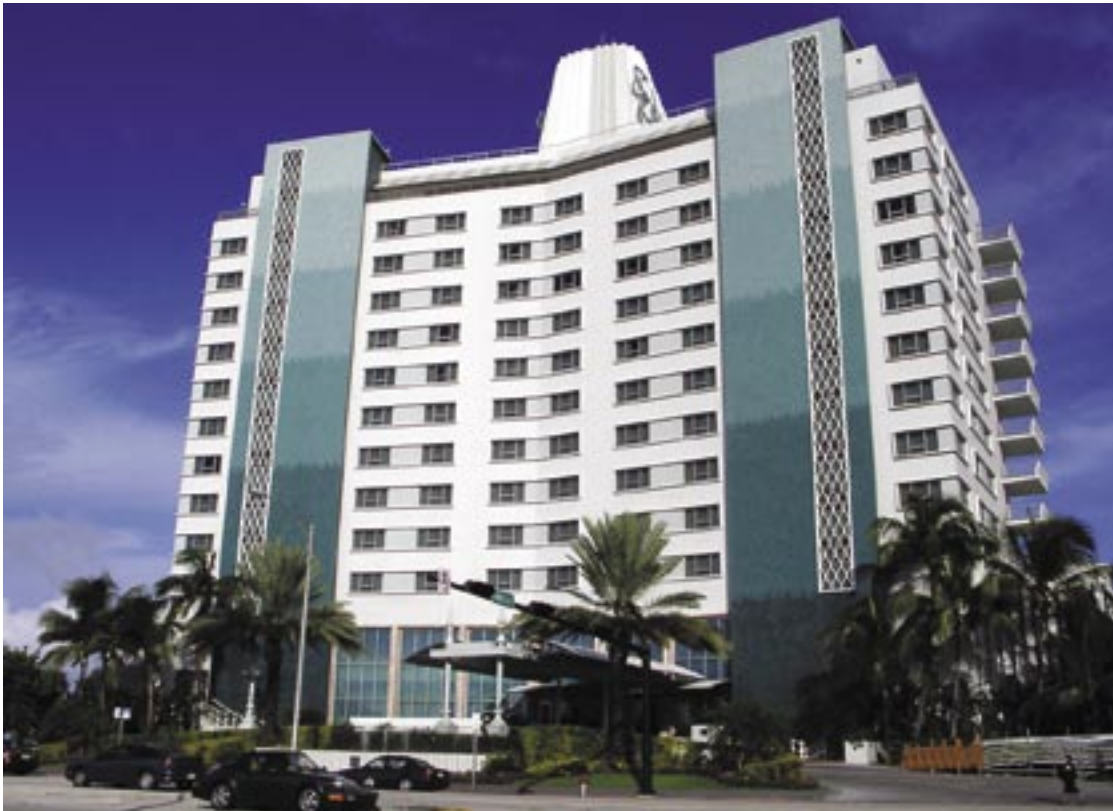
Eden Roc Hotel entrance with its two tiled towers in their full glory

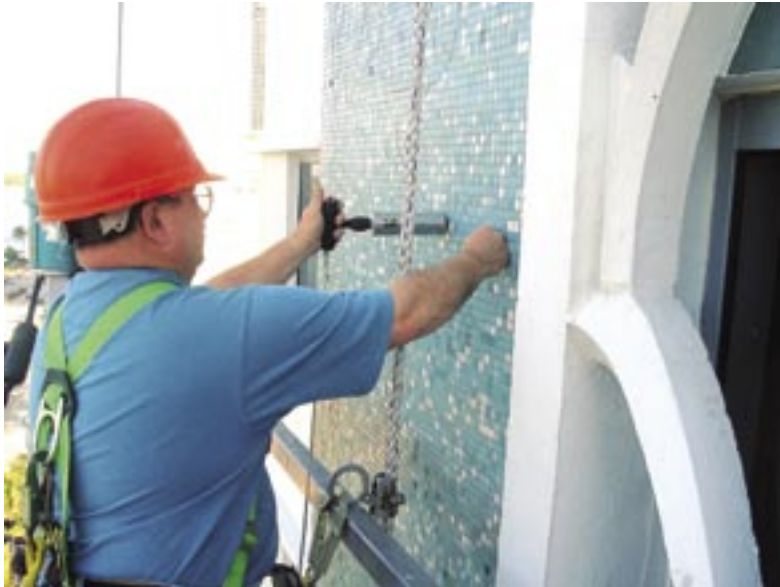
Selective core samples were also extracted to examine the grout itself. Both the impact echo testing and selective core samples indicated that the debonding occurred throughout the wall cross section. Debonding occurred at the tile/grout interface, within the grout, and at the grout/CMU interface. The testing revealed that portions of the grout matrix was compromised and disintegrated. The grout joints were also severely

weathered resulting in missing, disintegrated, and friable grout joints. The conclusion was that severe exposure to the harsh sun and moisture of the southern Florida environment caused the degradation of the tile support system.

The impact echo testing in operation. The device demonstrated is the hammer sounding and transducer. Note the portion of the wall above the area being examined. The Xs on the wall indicate areas of delamination

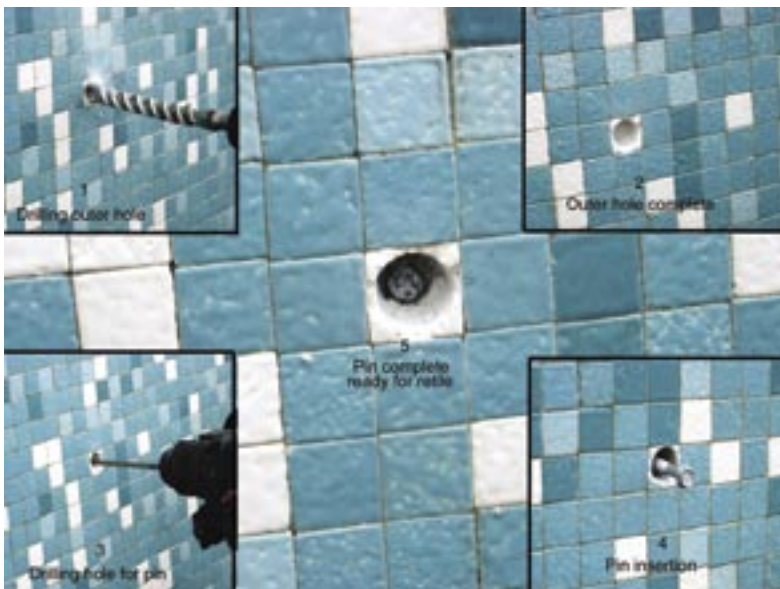
The complete process of pin insertion. Step 1 in the upper left shows the outer hole being drilled with Step 2 in the upper right showing the completion of the outer hole. Drilling for the self tapping screws is shown in Step 3 in the lower left with a partially inserted pin shown in Step 4. The middle of the photo shows Step 5, a full inserted and screwed down pin. The hole is then grouted and a new tile set

After pinning the entire tile surface on a 24 in. (61 cm) grid with self tapping masonry screws, the vacuum/injection access was established by drilling 3/8 in. (1 cm) holes through the tile in areas of the delaminations. The holes were drilled through the face of the tile intersecting the various levels of the delaminations. Due to the numerous areas of damaged and missing tile all openings and voids in the tile were first grouted flush to the tile surface as a temporary means of sealing the surface to accommodate the vacuum process. Additionally, missing and deteriorated grout in the tile joints was regouted to assist in providing a seal where the joints were porous or friable.

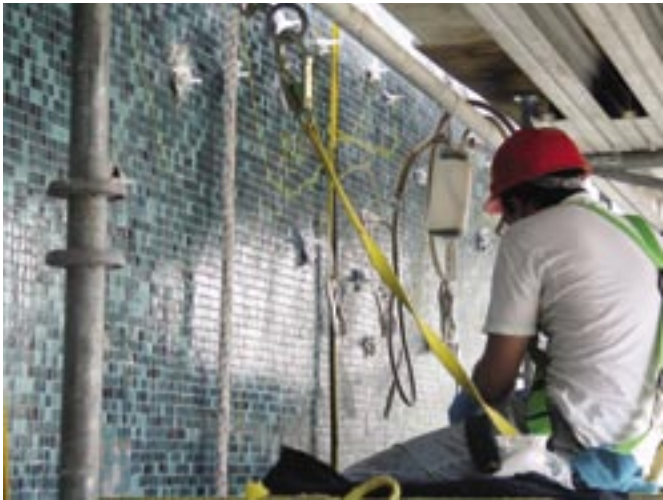
The layout of the MMA vacuum injection process. Note the clear tube inserted into the red port at the top of the photo. This hose is attached to the vacuum pump creating the vacuum at the top of the delamination. The bottle hanging from the railing contains a portland cement enhanced mixture of MMA that is being drawn into the wall at the white port. The process required hundreds of ports

Ports were inserted into the holes that served as both a vacuum exit and an entry to introduce the MMA. The vacuum lines were attached at the top or above the delaminations and MMA feed lines were attached at the bottom and middle of the areas to be filled. MMA was introduced from 0.26 gal. (1 L) closed containers. In the many of the delaminated areas, the MMA was mixed with portland cement to accommodate the larger cavities and voids.

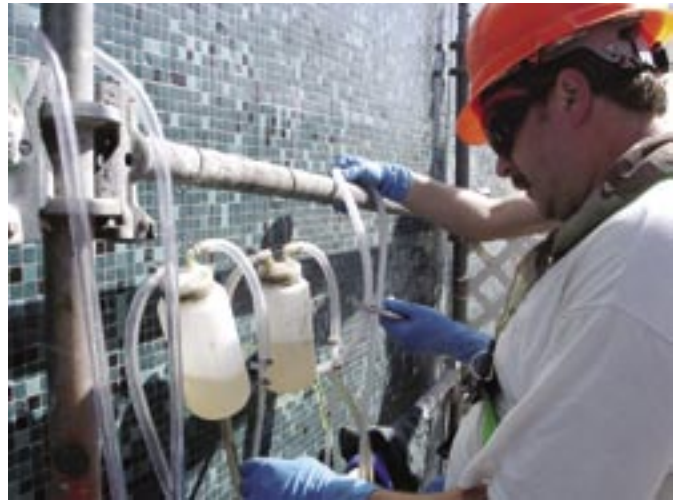
A worker monitors the injection process. The vacuum port is above, out of view from the camera

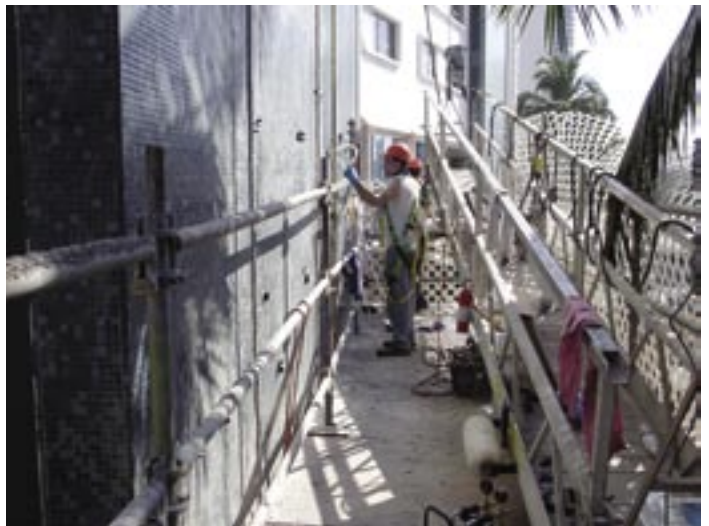
The vacuum process being performed at ground level. The vacuum pump is seen in the right center of the photo under the swing stage. A spare pump is seen at the bottom of the photo

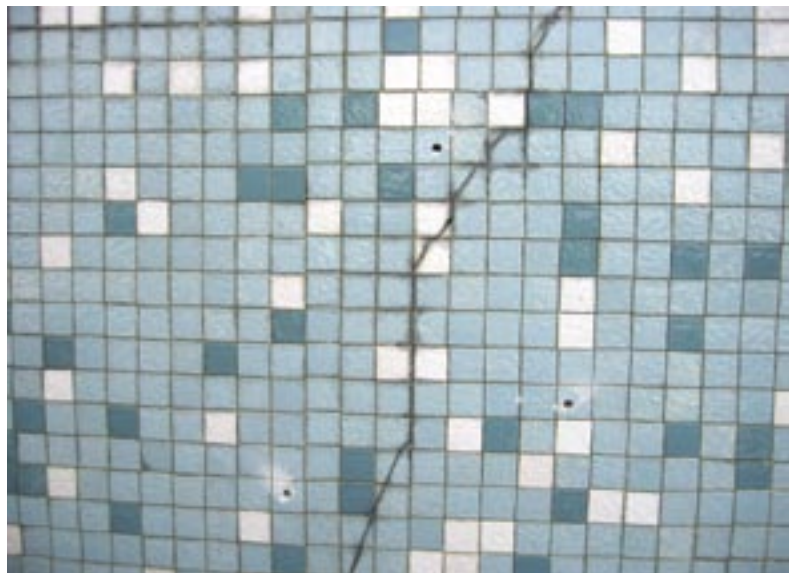
Layout of additional pins inserted for crack stitching

echo testing revealed that the CMU was intact, thus a technique of pin stitching was utilized to tie the cracked tile to the CMU prior to vacuum injection along the length of each crack.
