Howard Street Bridge Over I-83 Restored Utilizing Fox Industries, Inc. Protective Coatings

www.foxind.com FN-314

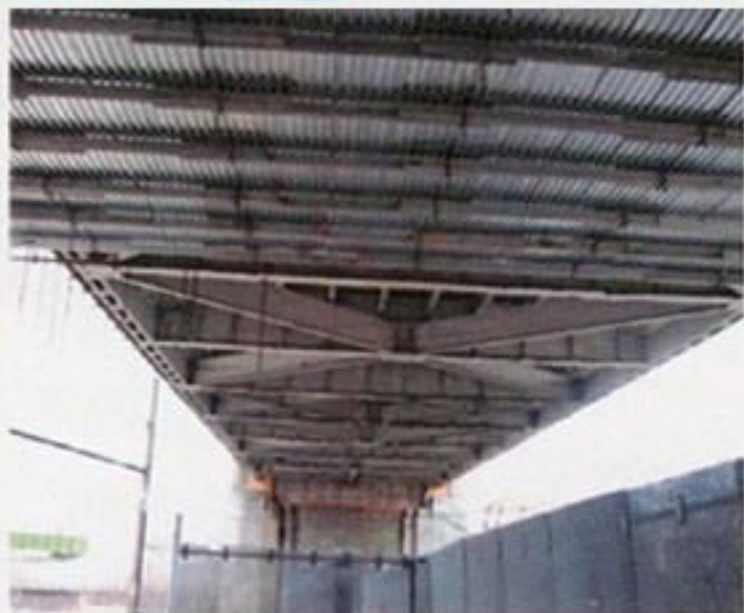
Steel surfaces below the roadway were cleaned using pressure washer capable of 4500 psi at nozzle with a zero tip.

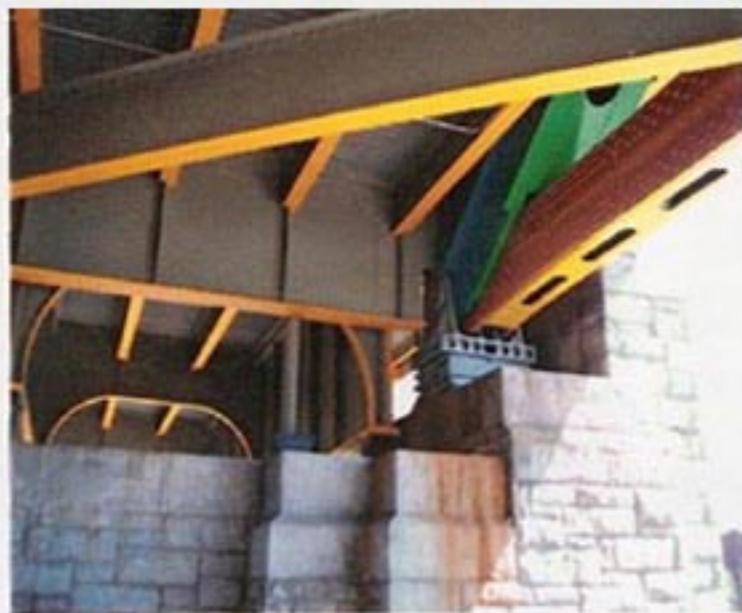
After cleaning, the structural steel below the roadway received two coats of FX-501 M Elastomeric Coating at 8.0 to 10.0 mils DFT.

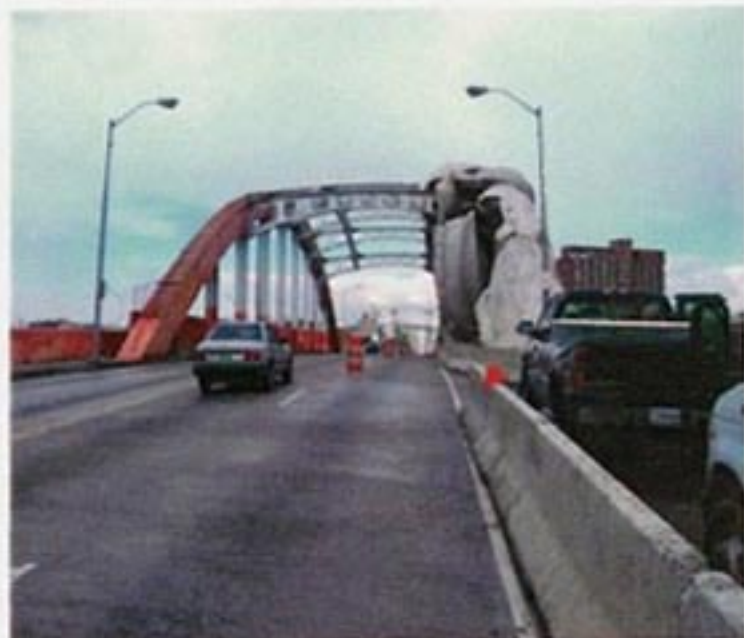
Steel surfaces above the roadway were abrasive blasted to an SSPC-SP10. Steel surfaces were primed with FX-408 Zinc Rich Primer at 3.0 to 5.0 mils DFT.

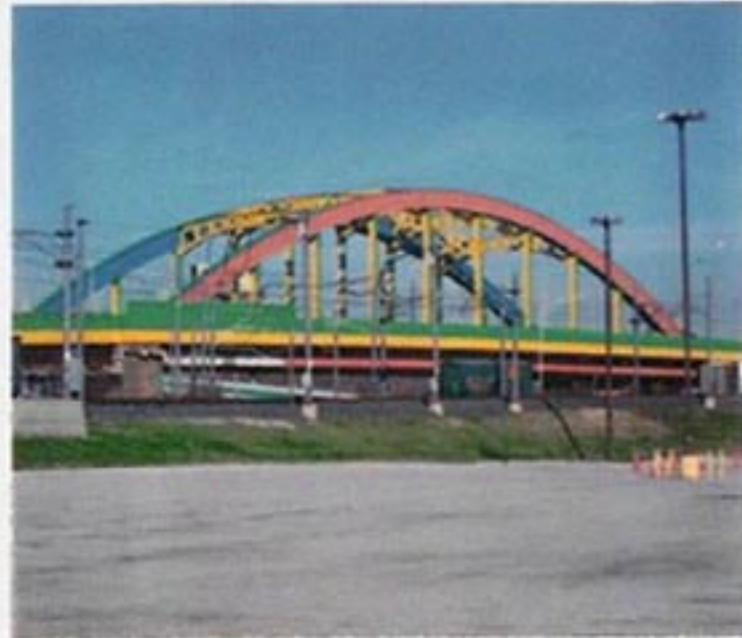
The protective coating system used above the roadway included an intermediate coat of FX-475 Epoxy Protective Coating, a pigmented finish coat of FX-442 Aliphatic Polyurethane and a top coat of FX-442 Anti-Graffiti Clear Polyurethane.
